A Study of the Effects of the Use of  
Imported Contaminated Granite Sub-  
base/Stone on Radon Gas Levels in  
Buildings

Richard Waters

## 2- Introduction:

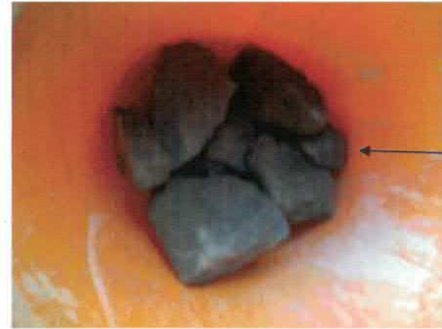
Size of Granite sub/rock  
Taken from remedial works

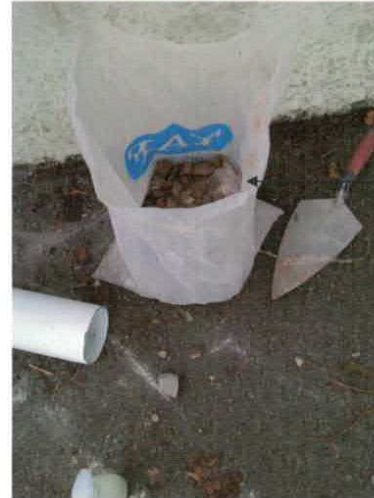
Evidence of Material Collected

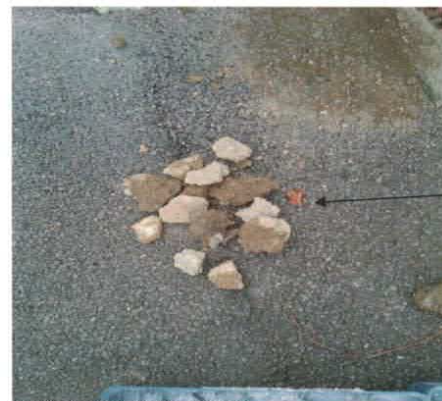
Sub Base Rock Material

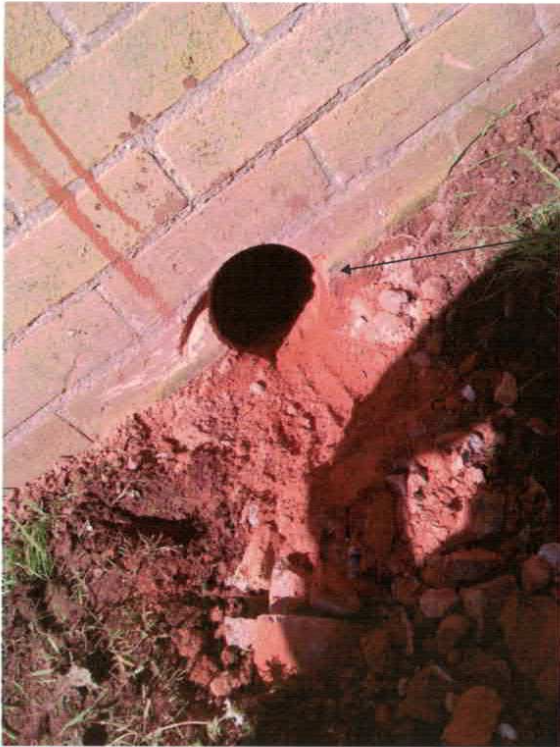
Typical Core Hole into Sub base of Building of where Extracts were taken from

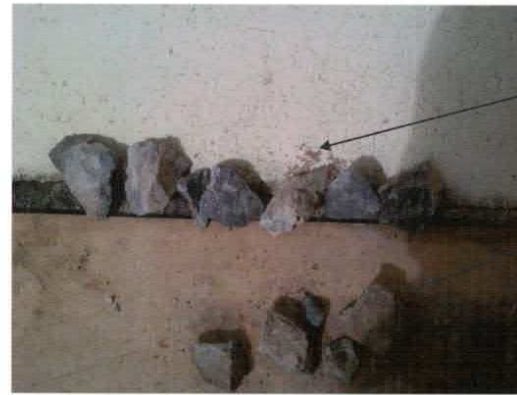
Samples of different Rocks and Sizes  
Have been taken from remedial works

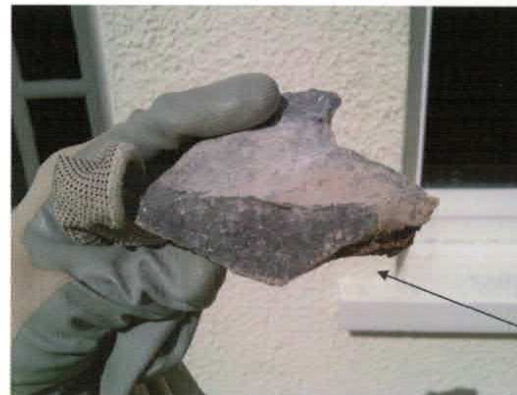
Size of Sample Taken from Sub Base

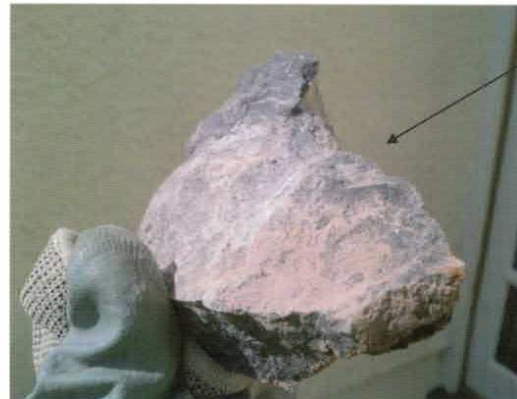
Each box was labelled with the location of the infill used and the monitor numbers:

For the experiment large plastic containers were used, one for each location. The infill from each location was placed into the containers along with a monitor. The containers were then sealed with tape in order to prevent contamination of the results by the external atmosphere. The containers were labelled with the relevant locations, the monitor numbers and the amount of time the experiment would continue for.

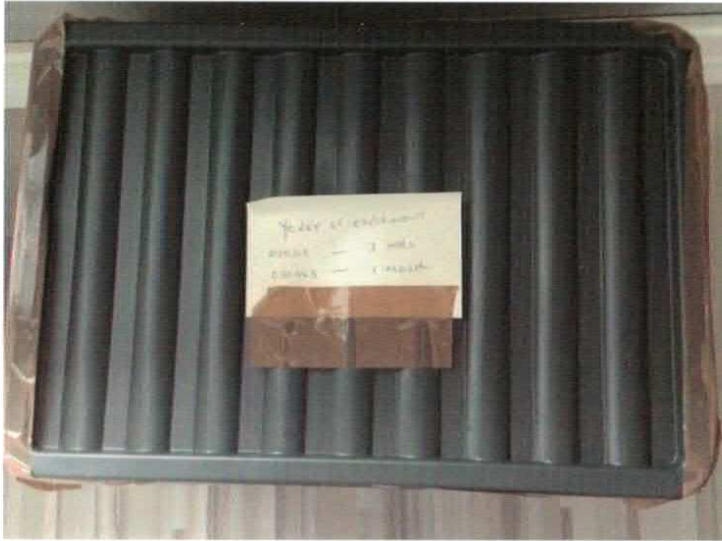
Each monitor was placed on top of the infill in the containers:

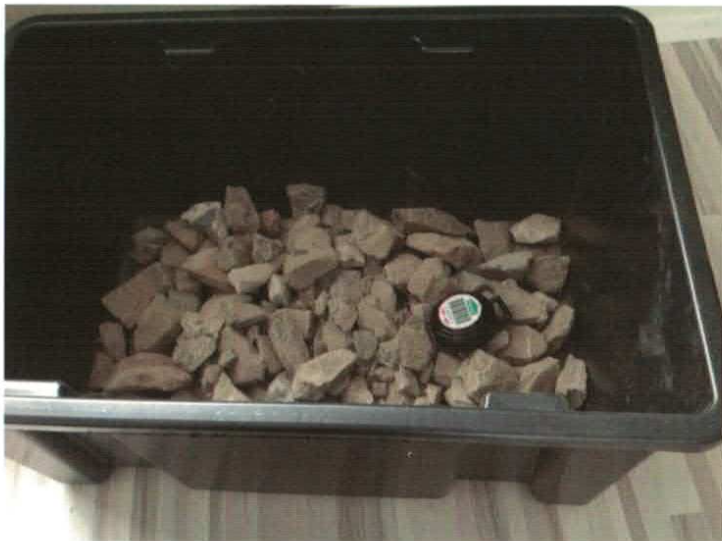
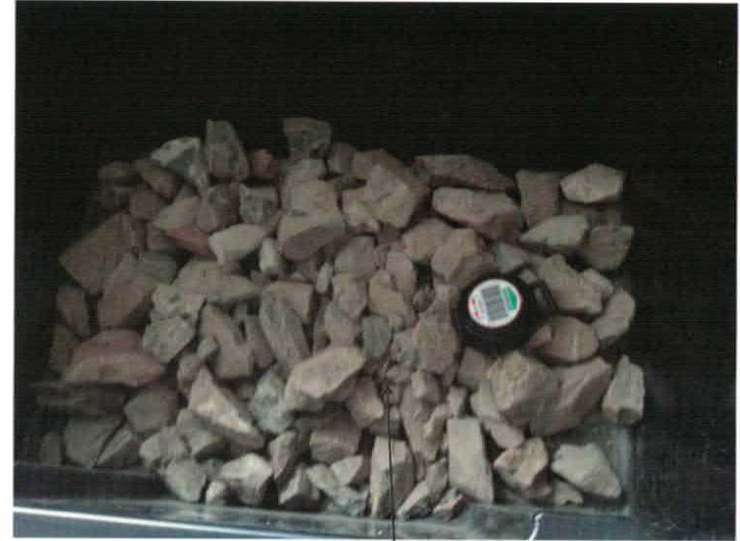
Different sizes of rock samples.

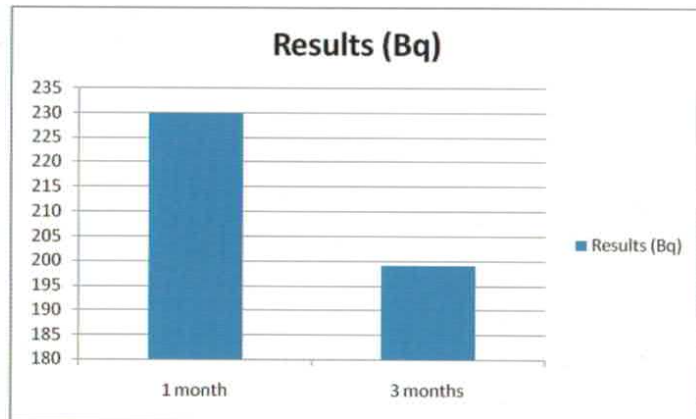
Length of time each Radon Monitor was in the sealed container	Test result
1 Month Test	230 Bqm <sup>3</sup>
3 Month Test	199 Bqm <sup>3</sup>

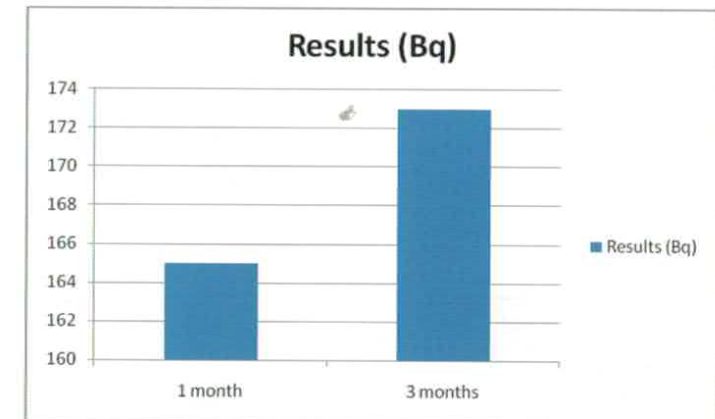
Length of time each Radon Monitor was in the sealed container	Test result
1 Month Test	165 Bqm <sup>3</sup>
3 Month Test	173 Bqm <sup>3</sup>

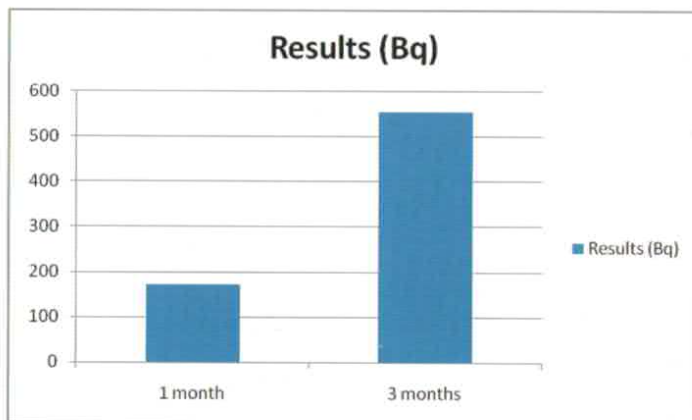
Length of time each Radon Monitor was in the sealed container	Test result
1 Month Test	171 Bqm <sup>3</sup>
3 Month Test	555 Bqm <sup>3</sup>

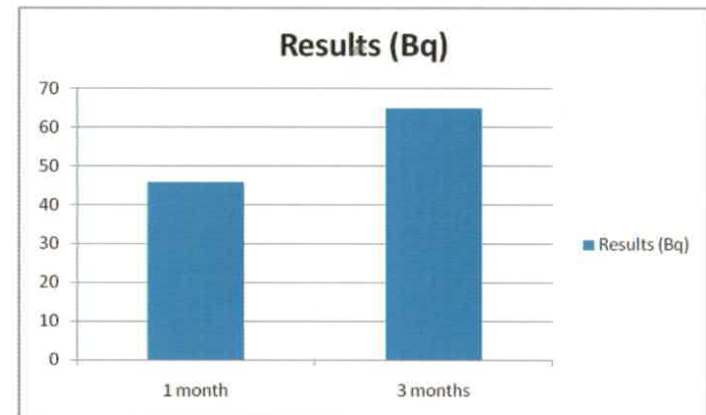
Length of time each Radon Monitor was in the sealed container	Test result
1 Month Test	46 Bqm <sup>3</sup>
3 Month Test	65 Bqm <sup>3</sup>

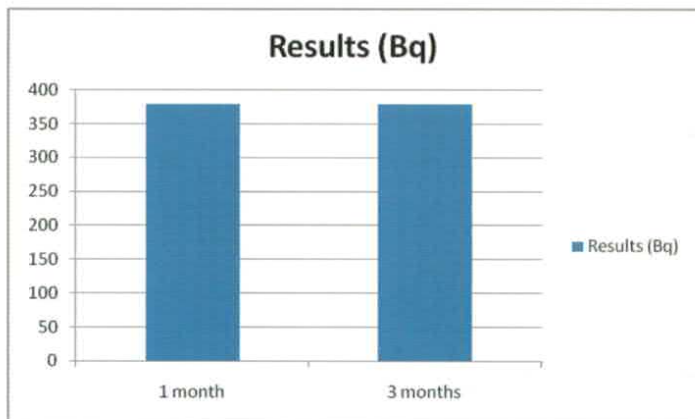
Length of time each Radon Monitor was in the sealed container	Test result
1 Month Test	380 Bqm <sup>3</sup>
3 Month Test	380 Bqm <sup>3</sup>

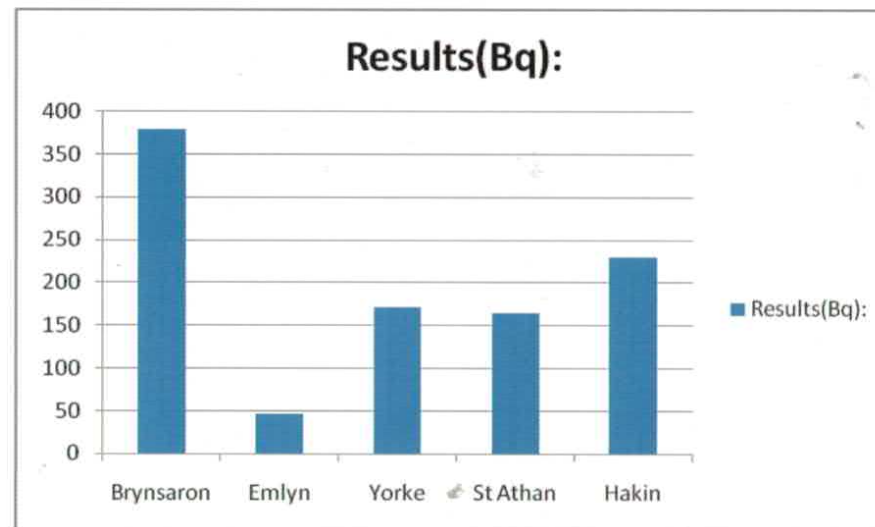
**Results of the 1 month experiment:**

Address	Date carried out experiment	Result after 1 month
Brynsaron School	24/8/2012 – 24/9/2012	380 Bqm <sup>3</sup>
Ysgol Gyfun Emlyn	17/8/2012 – 17/9/2012	46 Bqm <sup>3</sup>
Yorke Street	09/7/2012 – 9/8/2012	171 Bqm <sup>3</sup>
RAF St Athan	26/6/2012 – 26/7/2012	165 Bqm <sup>3</sup>
Hakin	14/6/2012 – 14/7/2012	230 Bqm <sup>3</sup>

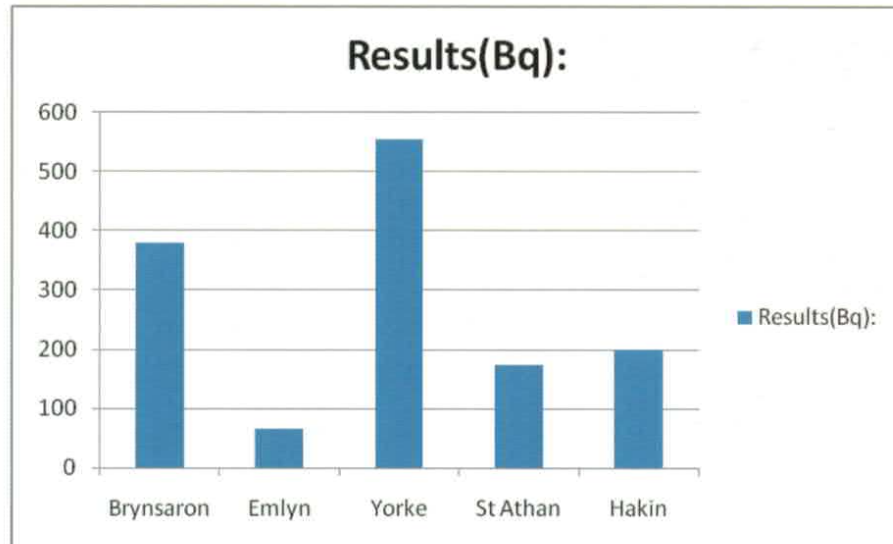
### Results of the 3 month experiment:

Address	Date carried out experiment	Result after 3 month
Brynsaron School	24/8/2012 – 24/11/2012	380 Bqm <sup>3</sup>
Ysgol Gyfun Emlyn	17/8/2012 – 17/11/2012	65 Bqm <sup>3</sup>
Yorke Street	09/7/2012 – 9/10/2012	555 Bqm <sup>3</sup>
RAF St Athan	26/6/2012 – 26/9/2012	173 Bqm <sup>3</sup>
Hakin	14/6/2012 – 14/9/2012	199 Bqm <sup>3</sup>

The results collected, show that the use of local contaminated quarried granite, does in fact contribute to high radon levels in buildings. The Quantity of granite rocks runs into tons of imported materials clearly increasing the risk of raised levels. Building regulations should pay particular attention to this as contaminated sub/base is being introduced to areas not recognized as risk areas.

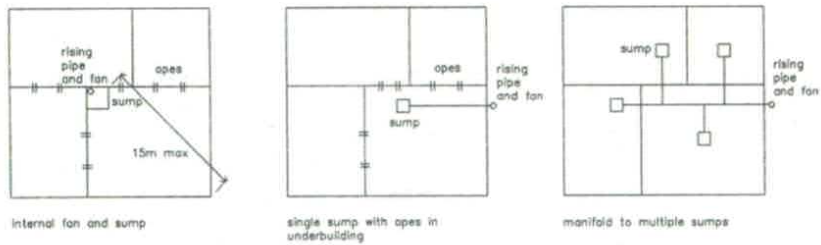
Fig 4 sump layout options

- 1) A radon membrane should be installed in every new build/ extension in Wales by a qualified radon remedial installation expert and on our evidence alone in areas where there is supposed to be low risk is now incorrect.
- 2) Every new build should have secondary preventative measures installed i.e. a sump with pipe work, as shown in Fig 4 and 5:

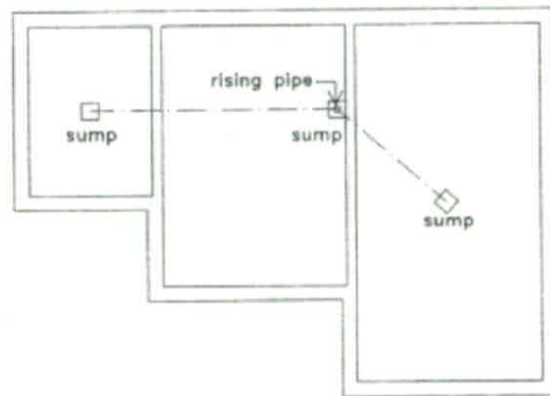
Fig 5 interconnected sumps
